# Manhole Inspection Summary

Manhole # S04II2019MH

Insp Date: **7/14/06 11:11 AM**

**Location** Address: **3200 NERAK RD**

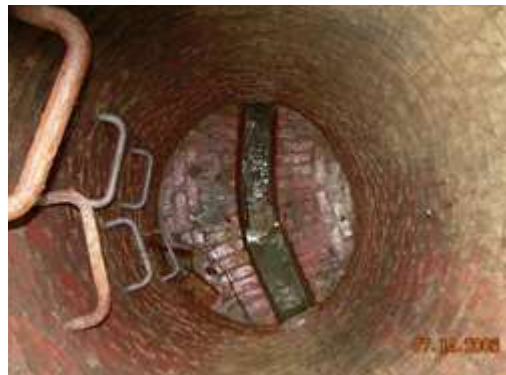
Top View

Corroded steps. Evidence of surcharge - Bench debris. Channel debris.

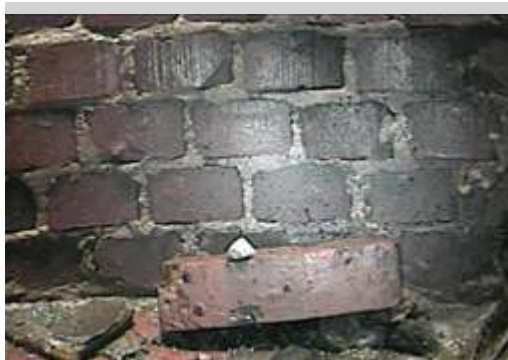
Bench debris

Bench debris.

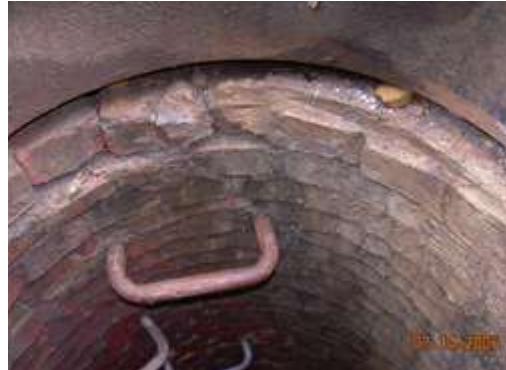
Defect

Frame leaks. Adjustment deterioration, loose brick and cracks. Adjustment infiltration.

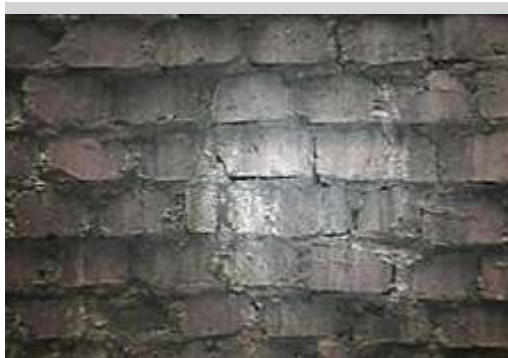
Defect

Corbel deterioration and infiltration.

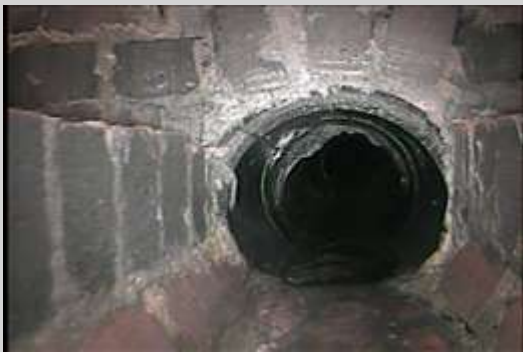
### 8 in. Circular Gravity Sewer Pipe Out @ 12 O'Clock

Comments **The O12 pipe picture shows grease deposits in the Channel as well as root intrusion inside of the pipe. The O12 pipe seal is not flush to the pipe. The I5 pipe seal is not flush to the pipe.**

Deposits: ☐ None ☐ Mud ☐ Sludge ☒ **Debris** ☒ **Grease**

Infiltration: **Evidence** Pipe Seal Cond: **Roots**

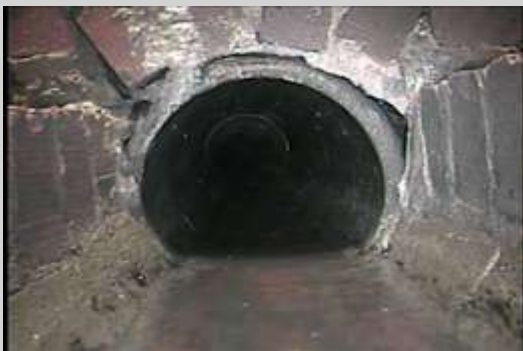
### 8 in. Circular Gravity Sewer Pipe In @ 5 O'Clock

Deposits: ☐ None ☐ Mud ☐ Sludge ☒ **Debris** ☒ **Grease**

Infiltration: **Evidence** Pipe Seal Cond: **Unknown**
